City of Springfield, Missouri

SMOKE TEST

Date: 6, 6, 97 Line Segment: (JCH) N21NW024 to (JCH) N21NW025
 Temperature (°F): 4 1 = 110-90 2 = 89-80 3 = 79-70 4 = 69-0 Crew: GW # C
 Ground Conditions: 7 1=Dry 2=Moist 3=Wet 4=Saturated Precipitation: 7 1=Dry 2=Drizzle 3=Rain
 Last Rain Event: 5, 30, 97 Total Footage: 228 228 BT Pipe Diameter: XUCP Measurement Type: 1
 Comments: _____
 1=Field Measurement
 2=Sta. 3=Scaled

SMOKE PHOTO

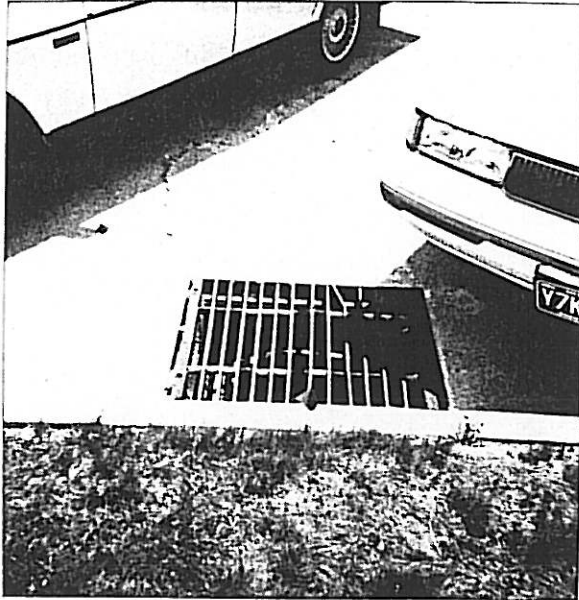
JC14 N21NW025
N21NW024
1112 N. GLENSTONE
AVE
AREA DRAIN
S-2
T-1000
239' FROM DOWNSTREAM

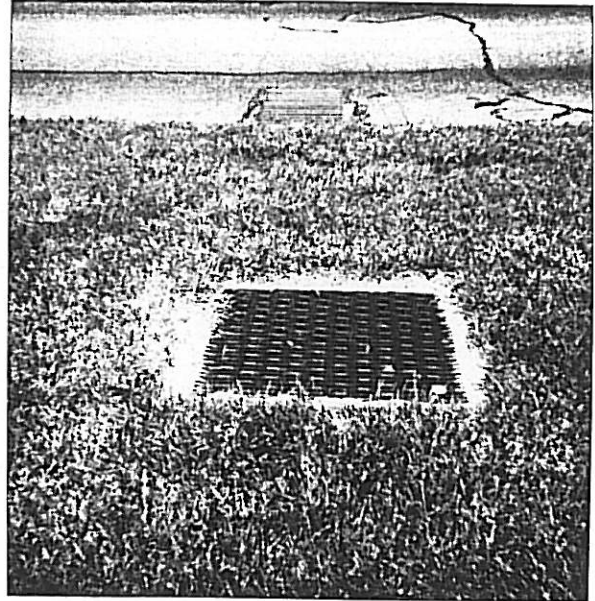
JC14 N21NW025
N21NW024
1112 N. GLENSTONE
AVE.
AREA DRAIN
S-2
T-1000
193' FROM DOWN
STREAM

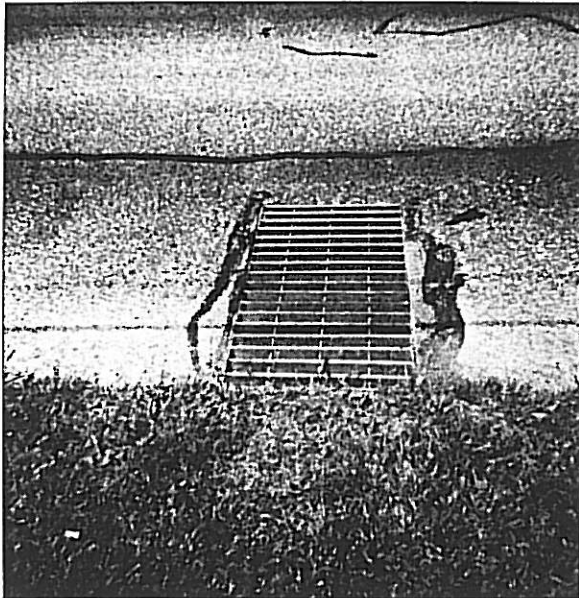
N21NW025
N21NW024
1112 N. GLENSTONE
AVE.
CURB INLET
S-2
T-999,999
193' FROM DOWNSTREAM
